Report No. 131500-603  
14 January 1977

INTERIM TEST REPORT  
ON THE SHOCK-DROP TEST  
OF THE  
AN/TRN-41 TACAN NAVIGATIONAL SET

This test report is an interim report describing the failure and the proposed corrective action resulting from the Shock-Drop test on the AN/TRN-41 TACAN Navigational Set. After the corrective action has been taken, these tests will be repeated.

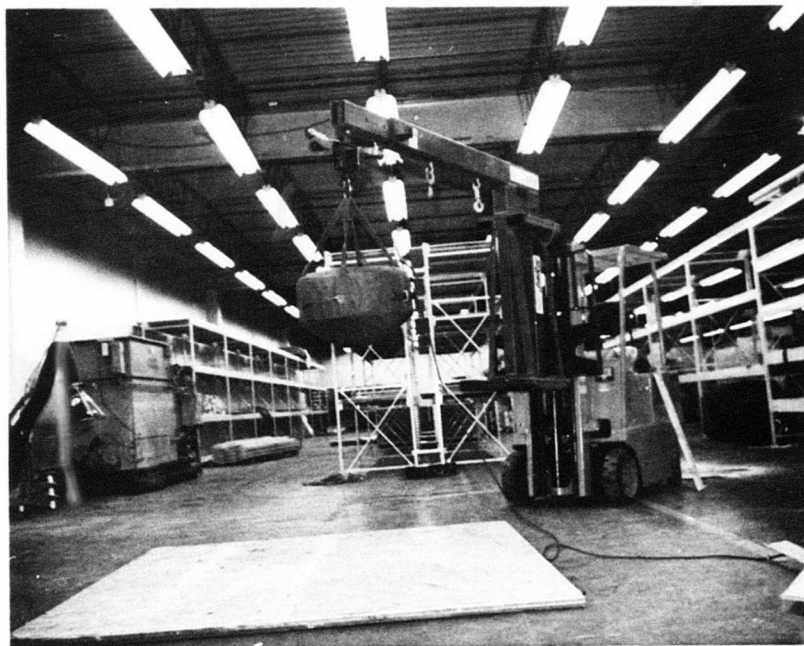
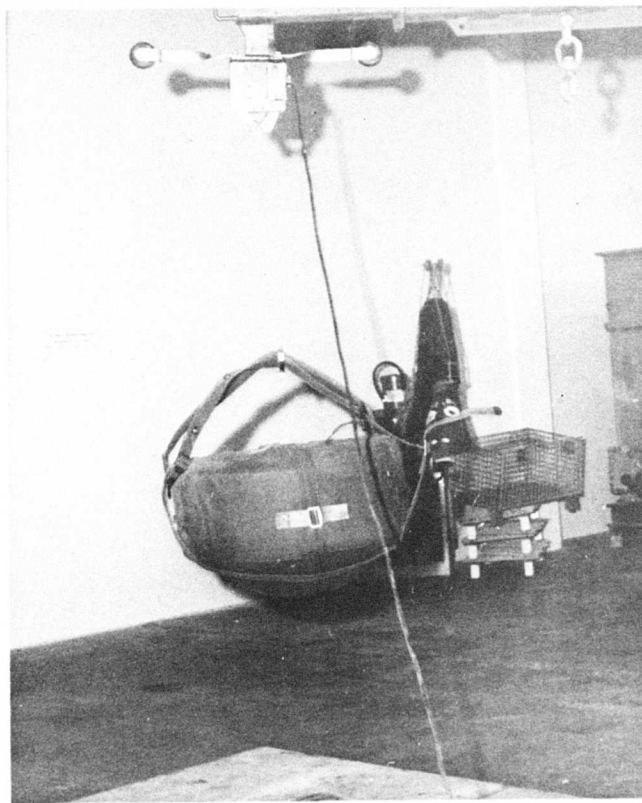
ANTENNA 48" DROP TEST

c. Drop Test - Antenna (Manportable Configuration). This unit incurred major damage as a result of the drop test. An itemized list of the damage noted by Quality Assurance is included as part of the data sheets. The major problem areas are as follows:

(1) The upper radome cracked.

(2) The lower radome cracked.

(3) Damage was done to the 15 Hz and 135 Hz rotating drums, caused from making contact with the radome.

(4) Pedestal base broke.

b. Antenna Unit. The antenna unit incurred damage with two types of drops. First, an angular drop on the upper radome such that the radome was deformed, damaging the 15 Hz and 135 Hz rotating drums. Second, the angular drop on the lower portion cracked the pedestal and lower radome.

The antenna pedestal was redesigned by removing the compass and reducing its height. A nylon ring was added to the top of the radome to mount the compass during alignment. At all other times, the compass will be with the ancillary equipment. The design of the compass will change from the north seeking type to a 360° type - it will be the same compass that is used in the AN/TRN-26 system. The reduction in height of the pedestal allows the packing to be arranged so that the center of gravity is closer to the man's back.

The smaller pedestal is packed so that the drop shock is not concentrated on the flange of the pedestal, but distributed over the lower section of the antenna.

The upper radome was strengthened by adding two plies of fiberglass across the sides and top of the radome. This strengthening now prevents the radome from touching the 15 Hz and 135 Hz rotating drums.

The packing design effectively increases the density of the pack around the antenna. This was accomplished by sandwiching 1/2-inch polyethylene with polyurethane. Around the base, the polyethylene was 1-inch thick. In addition, a 1/2-inch polyethylene sheet was placed completely around the circumference of the antenna replacing the existing polyurethane. The interior dimensions remained the same and the same canvas pack was used.

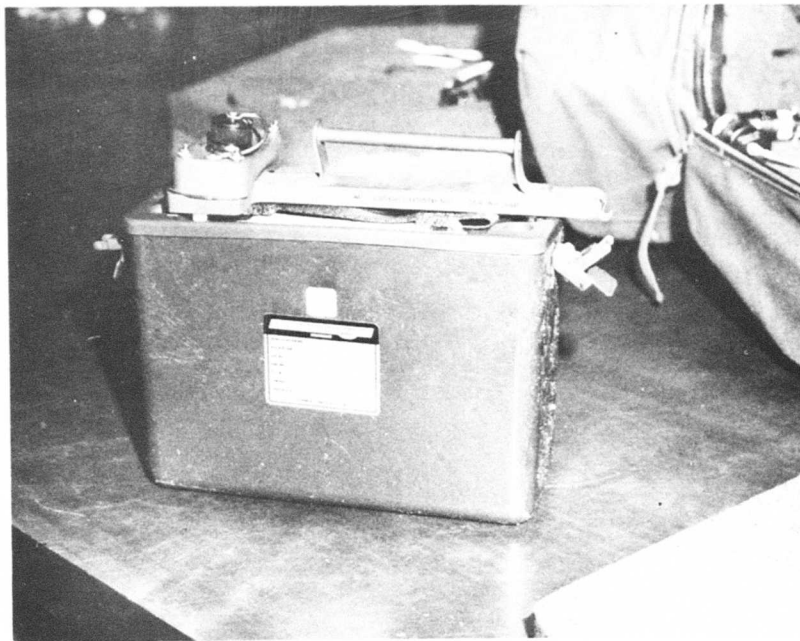
BATTERY AND ADAPTER AFTER 48" DROP TEST

(2) The battery adapter handle was bent; however, it was still functional.

c. Ancillary Group. The tripod and battery adapter handle were damaged during the drop test of the ancillary group.

The density of the packing surrounding the battery and battery adapter will be increased. In addition, the battery adapter will nest in the packing.

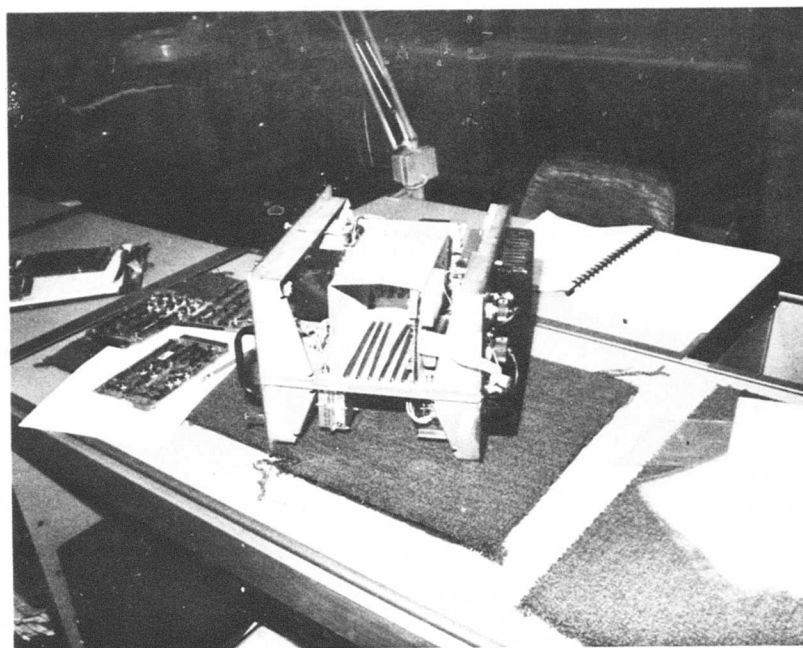
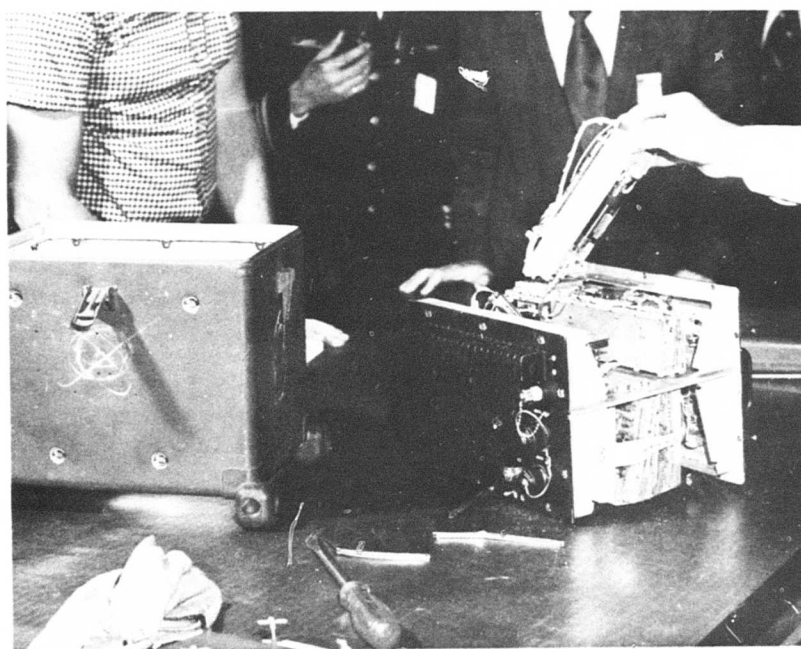
RT AFTER 48" DROP TEST

b. **Drop Test - Receiver-Transmitter.** This unit incurred major damage as the result of the drop test. An itemized list of damages noted by Quality Assurance is included as part of the data sheets. A study of the damaged RT indicates that there are three areas in which corrective action will be required in order for this unit to pass this test. These are as follows:

(1) Rubber bumper blocks. These blocks failed to protect the RT on the rear heat sink side. The blocks were not large enough, which allowed the heat sink to hit the floor, causing a severe shock to the RT.

(2) Card Rack. The card rack securing the seven circuit card assemblies deformed badly. All of the connectors used in securing the circuit cards broke; the card guides became twisted and deformed, and all circuit cards became loose.

(3) Synthesizer Chassis. The mounting flanges on this assembly broke off; therefore, this assembly became loose and caused major secondary damage.

a. Receiver-Transmitter (RT) Unit. The RT unit incurred major damage when it was dropped on the rear surface that mounts the heat exchanger. The rubber bumpers permitted the heat exchanger to strike the plywood floor with enough force to have an imprint of the exchanger on the floor. This severe shock deformed the rear of the case, broke the mounting of the synthesizer allowing it to float in the unit, and deformed the card cage so that the printed circuit cards became loose.

The rubber bumper blocks originally provided 1/8 inch clearance to the heat exchanger. This clearance has been increased by 1/2 inch and the area of these bumpers increased from 3.5 square inches to 9.0 square inches. The increase in depth and surface areas will prevent the heat sink from bottoming during drops.

The card rack has been redesigned to provide more rigidity so that the rack does not spring out of shape, allowing the cards to become loose and breaking the connectors. To increase the rigidity of the case, the aluminum composition and temper were changed, the rear connector plate was redesigned to one piece fastened to the side and top of the case, and the new front cover adds rigidity to the case by fastening to the sides at four places, in addition to supporting the printed circuit cards.

The synthesizer casting was redesigned to provide more rigidity and support at the top of the unit. The thickness of the mounting flange was increased to 1/16 inch and two bosses were added at the top of the casting to fasten to the braces. Braces were installed at the top of the unit from the front to the rear to provide support for the synthesizer and receiver.
